# Project: Evaluating the Performance of Existing Reinforcement for Oklahoma Bridges

David Darwin  
University of Kansas

Midwest Bridge Preservation Partnership

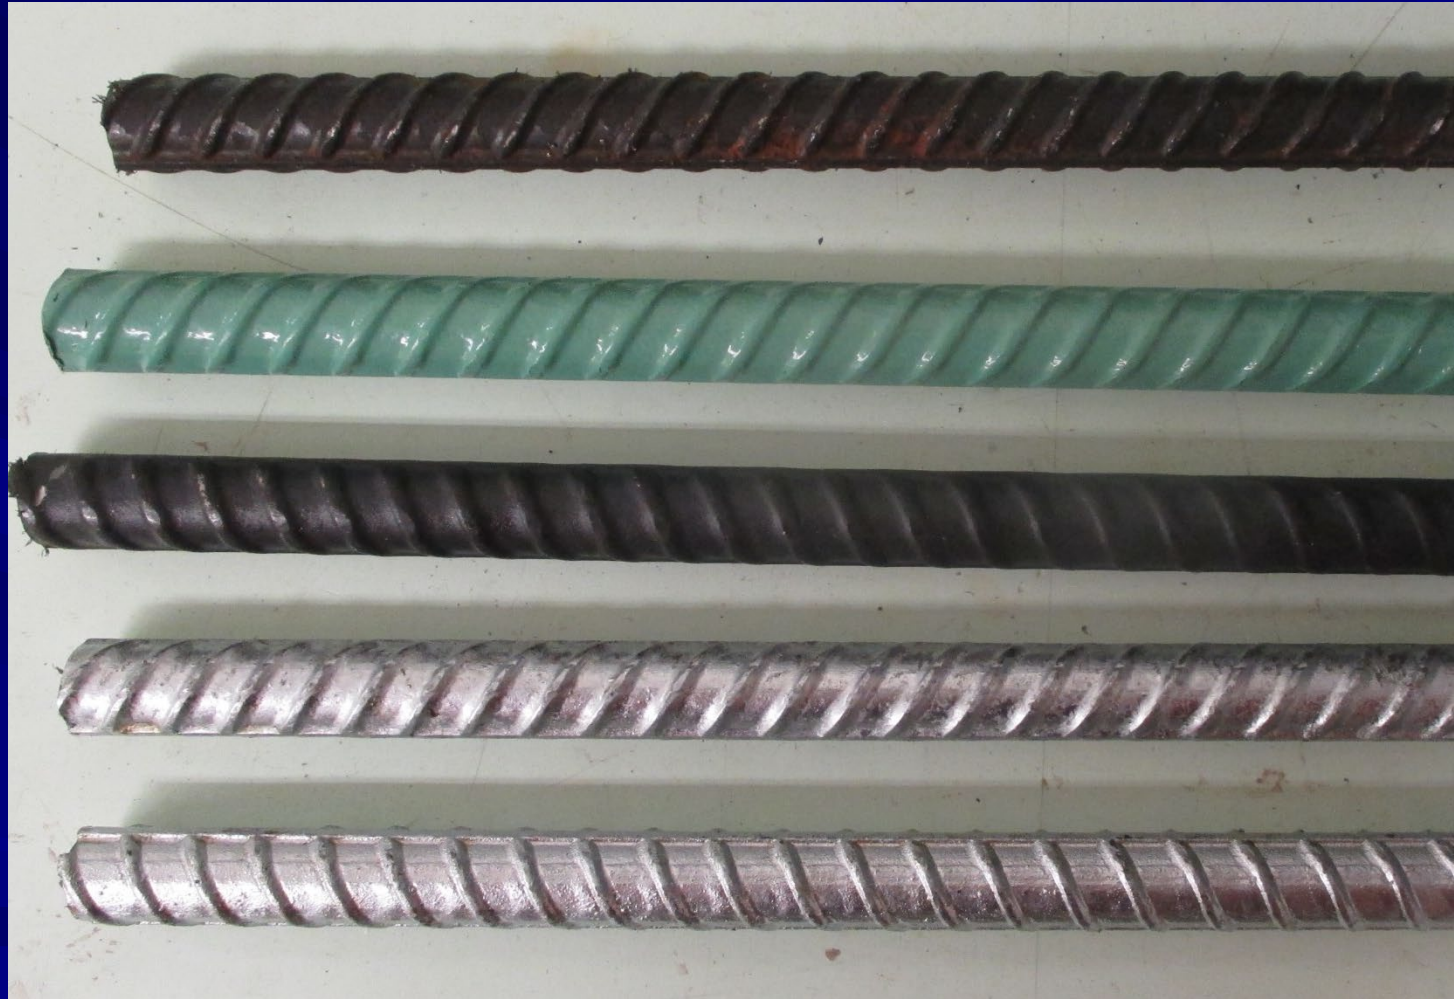
# Reinforcement

Conv

ECR

A1035

A767

A1094

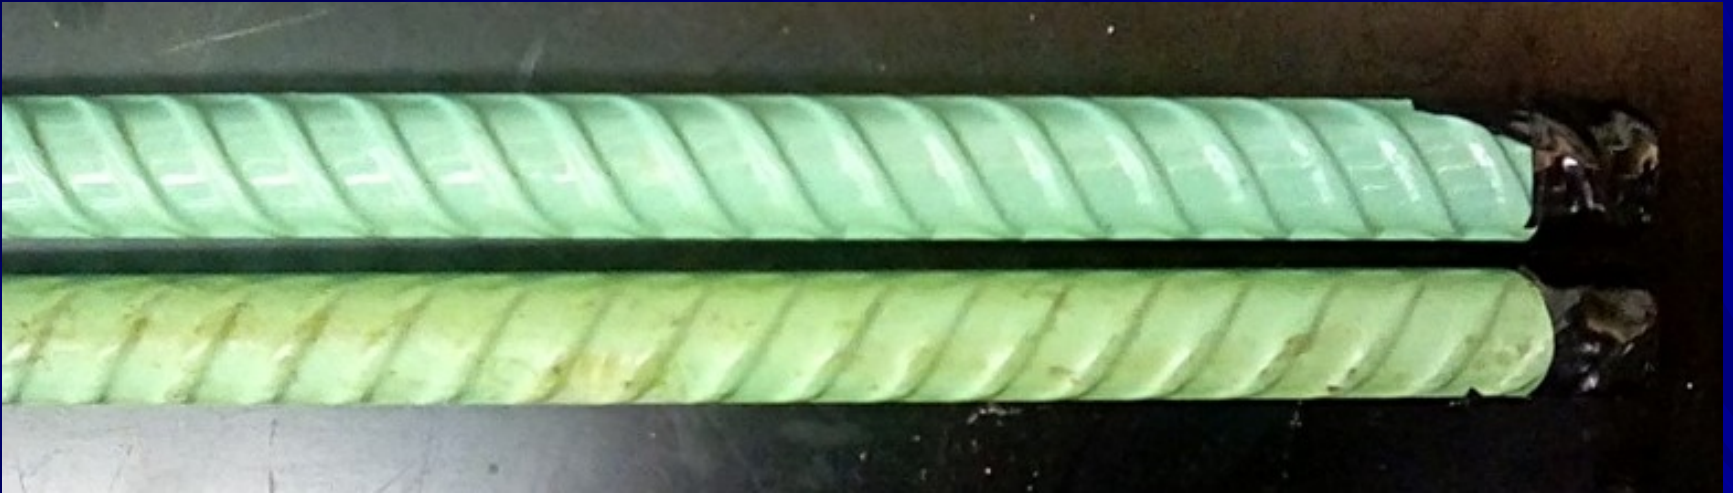
# ECR UV Exposure

- 1000 hours of UV exposure
- Additional specimens 100, 200, 250, 500 hours of UV exposure

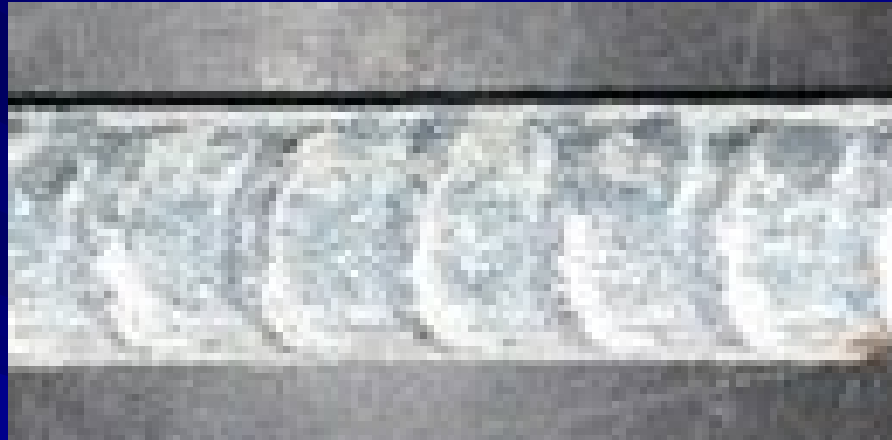
■ Uncracked

- More signs of corrosion at crack locations
- Greater penetration of  $\text{Cl}^-$  and carbonation at cracks

- Cow Creek deck panels show that bars are substantially protected in uncracked concrete but perform poorly at cracks
- Cost analysis over 100-years shows that ECR, A1035, A767, and A1094 provide cost-effective corrosion protection systems – 3-in. cover is more cost-effective than 2½-in. cover
