Emergency Vehicle (EV3):
Oklahoma is using EV3 for Load Rating

FAST ACT (2015) and Emergency Vehicles (EV's).

Γhe Eagle C	hief Creek	Bridge "A	" – SH 14
Noods Co.,

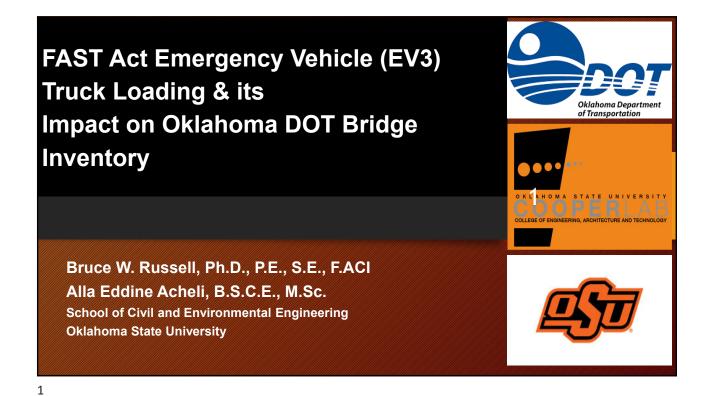
EV-3 LOADING:

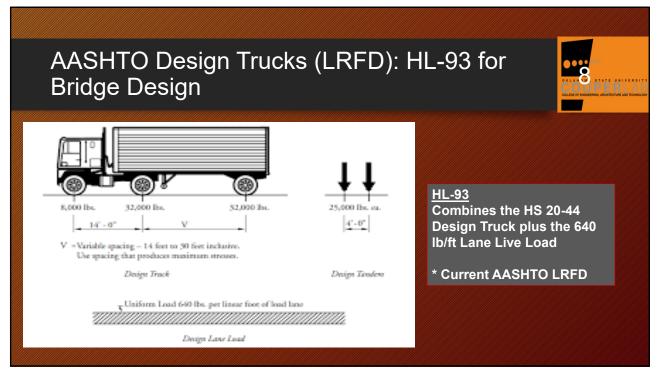
Legal Trucks for Interstate Highways Defined by the Interstate Highway Act of 1956 and the U.S. Code

- GVW < 80,000 lbs.
- **Single Axle < 20,000 lbs.**
- Tandem Axles < 34,000 lbs.
- 1974 Act invested the BRIDGE FORMULA
- State Laws are not uniform, and some exceptions are allowed by U.S. Code based on grandfathering provisions.
- States allow permit loads

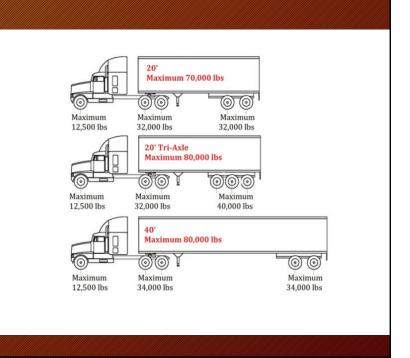
Legal Trucks by the U.S. Code §23 and the Bridge Formula

Trucks conforming to the Bridge Formula, a.k.a. "FORMULA B.

- The Truck Configuration at the lower right with five axles and 80,000 GVW is typical.
- The Bridge Formula allows rounding of 500 lbs., so the configuration shown at lower right is 80,500 lbs.
- Axle Tandems are spaced at 4 ft. with maximum tandem weight of 34,000 lbs.

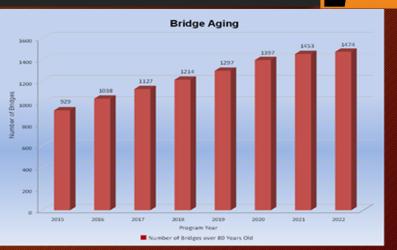
Oklahoma's Aging Bridges Number of ODOT Bridges 80 Years Old or Older

- With every passing year the Bridge Inventory AGES
- 1453 Span Bridges in the ODOT Bridge Inventory is 80 years old or older
- The Interstate Highway build-out is about 60 years old
- 600+ Steel Girder Bridges built in 1960's

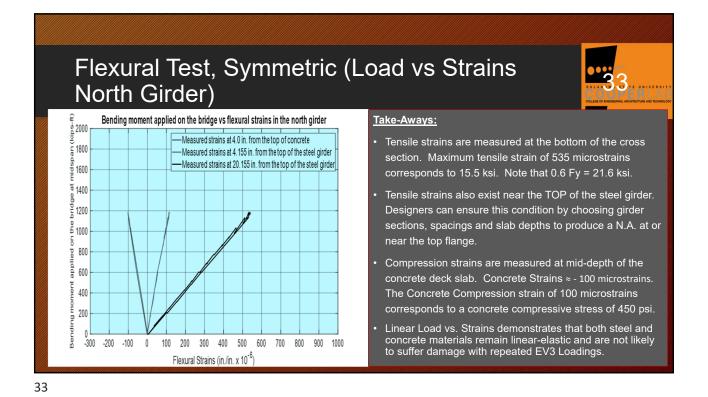
Midspan Strain Diagram for the North Girder (Symmetric Flexural Test) Take-away: Beam Behavior Governs And Beam Theory can be used to predict behavior and perform Load Rating Calculations Symmetric flexural test: Load applied: Pu = 140.19 kip Theoretical N.A Measured N.A Bonded foil gage 208.7μ -Δ=0.386" 110.4μ -101.7 u ... +139.2 μ +114.8 μ Bonded foil gage +532.5 μ +538.3 μ W24 x 94° North girder: Theoretical strains Measured strains

Conclusions: Flexural Testing

- Applied Loading exceeded the EV3 Loads by 4X.
- Despite large loads, P vs. Δ remains LINEAR.
- With Unloading, P vs. Δ remains elastic and rebounds to original deflection.
- The Bridge Response is Linear-Elastic and is NOT damaged during symmetric loading.
- Material Response (both Steel Girder and Concrete Deck) Remain Elastic under symmetric loading.
- Composite Bridge System is capable of supporting the EV3 Loading without Posting.
- Asymmetric Loading caused minor cracking in the deck slab but did not adversely affect Bridge Performance.

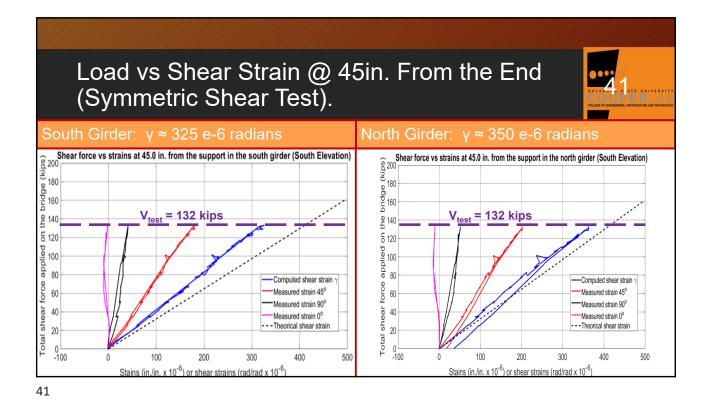
Strain Diagrams South Girder @ 45in. From the End (Symmetric Shear Test) Take-Aways: Symmetric shear test: (South girder 45.0 in.) The two girders share loads equally (South Elevation) (symmetric load test) Load applied: Pu = 164.7 kip Shearing strains remain linear elastic through test load that Theoretical N.A exceeds the EV3 load by 2.5X Vibrating wire gage Shear Stress (Test) = Gy ≈ 4.0 ksi. -29.2_µ 8.491 Shear Stress (Calculation): $\frac{V_{test}}{D \cdot t_w} = \frac{66 \, kips/girder}{32 \, in. \cdot 0.515 \, in.}$ -2.4μ Vibrating wire gage 25.809" +192.2μ Non-Linear bending strains indicate Bonded foil gage that shear distortion between composite slab and steel girder is significant. South girder 45 in: Measured strains

Conclusions: Shear Testing

- Applied Loading approximately EXCEEDED the EV3 Loading.
- P vs. Δ remains LINEAR.
- With Unloading, P vs. Δ remains elastic and rebounds to original deflection.
- The Bridge Response is Linear-Elastic and is NOT damaged during symmetric loading.
- Material Response (both Steel Girder and Concrete Deck) Remain Elastic under symmetric loading.
- Composite Bridge System is capable of supporting the EV3 Loading without Posting.
