# WBPP AGENDA

**Western Bridge  
Preservation  
Partnership**

### **Hydro-demolition rapid deck rehabilitation**

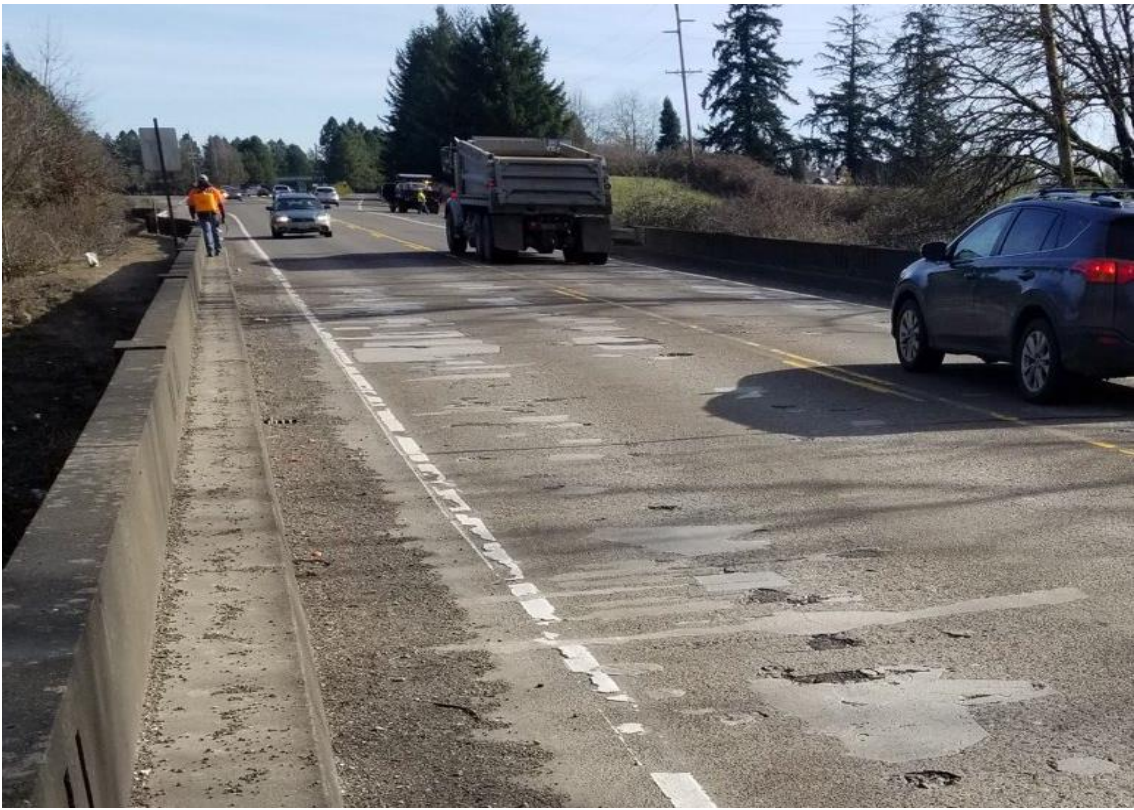
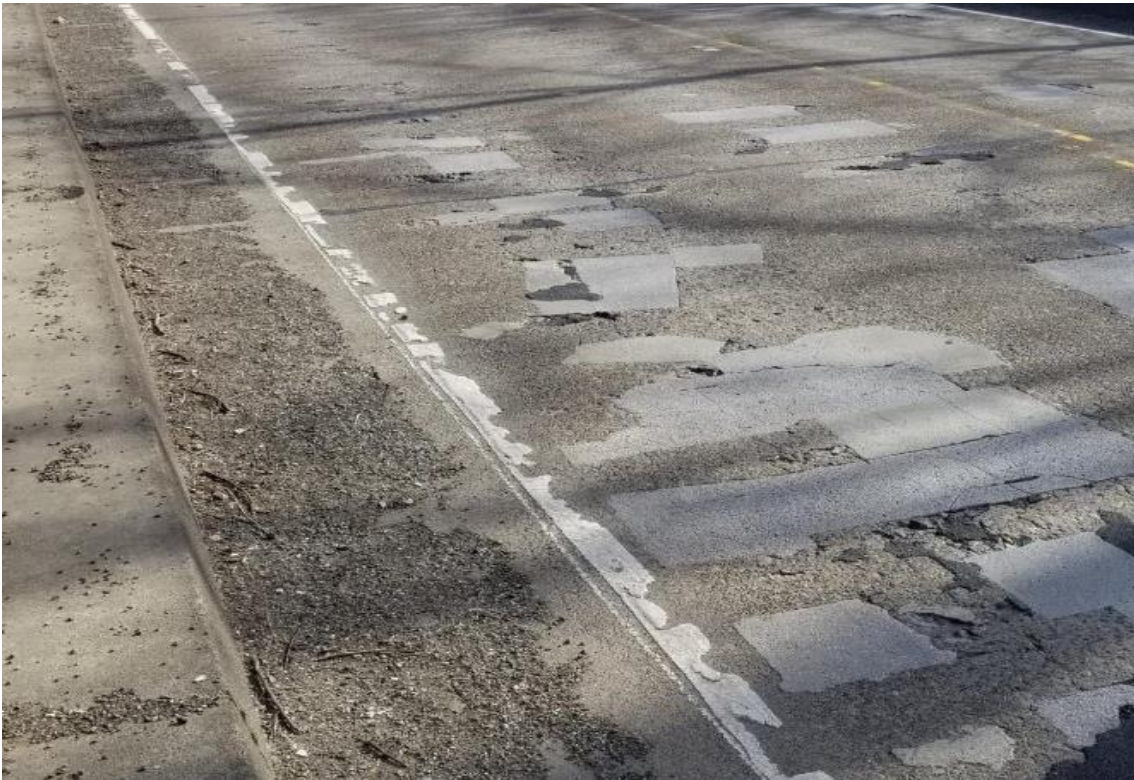
The reinforcement within the deck wasn’t placed at the proper depth which has led to significant spalling (potholing). An in depth evaluation of the deck was performed which confirmed chloride contamination in the surface concrete. Approximately 50% of the deck is expected to require patching.

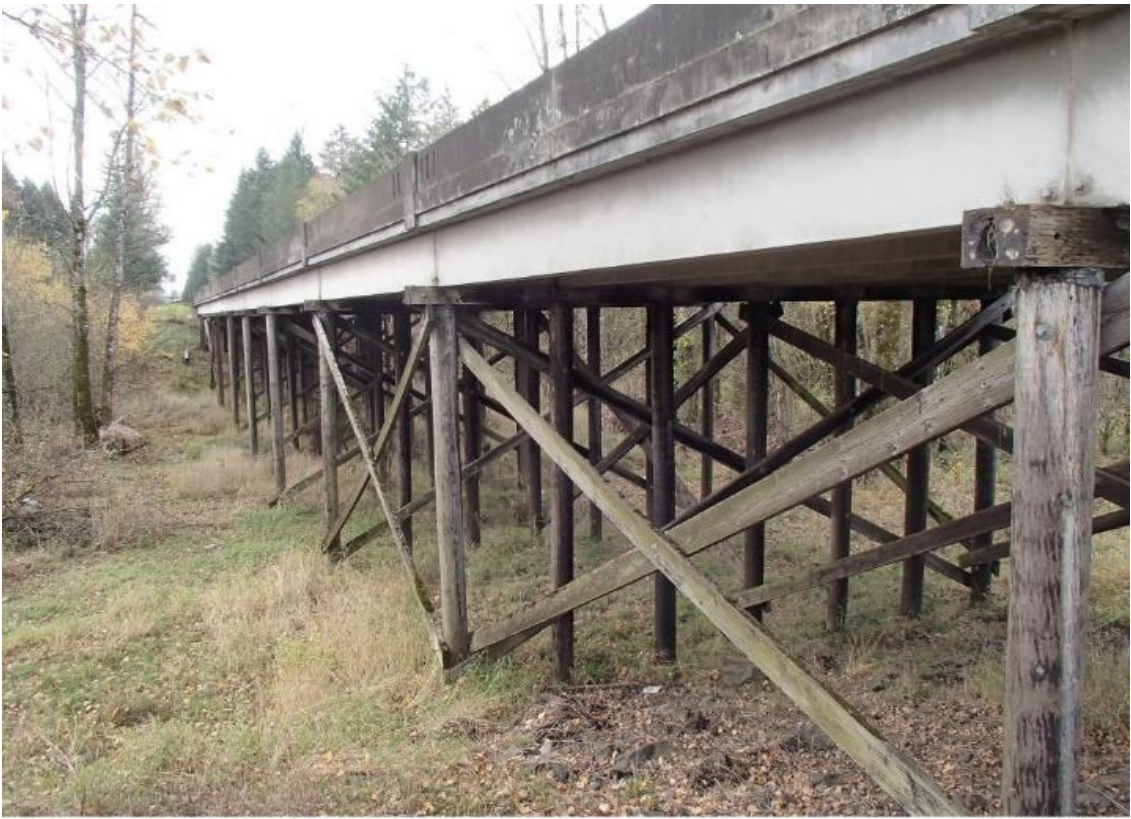
YAMHILL RIVER OVERFLOW - BR# 08492 - HWY 39 - MP: 45.76

SIDE ELEVATION
