# WBPP AGENDA

**Western Bridge  
Preservation Partnership**

### **Half Depth Deck Panel Preservation/Rehabilitation**

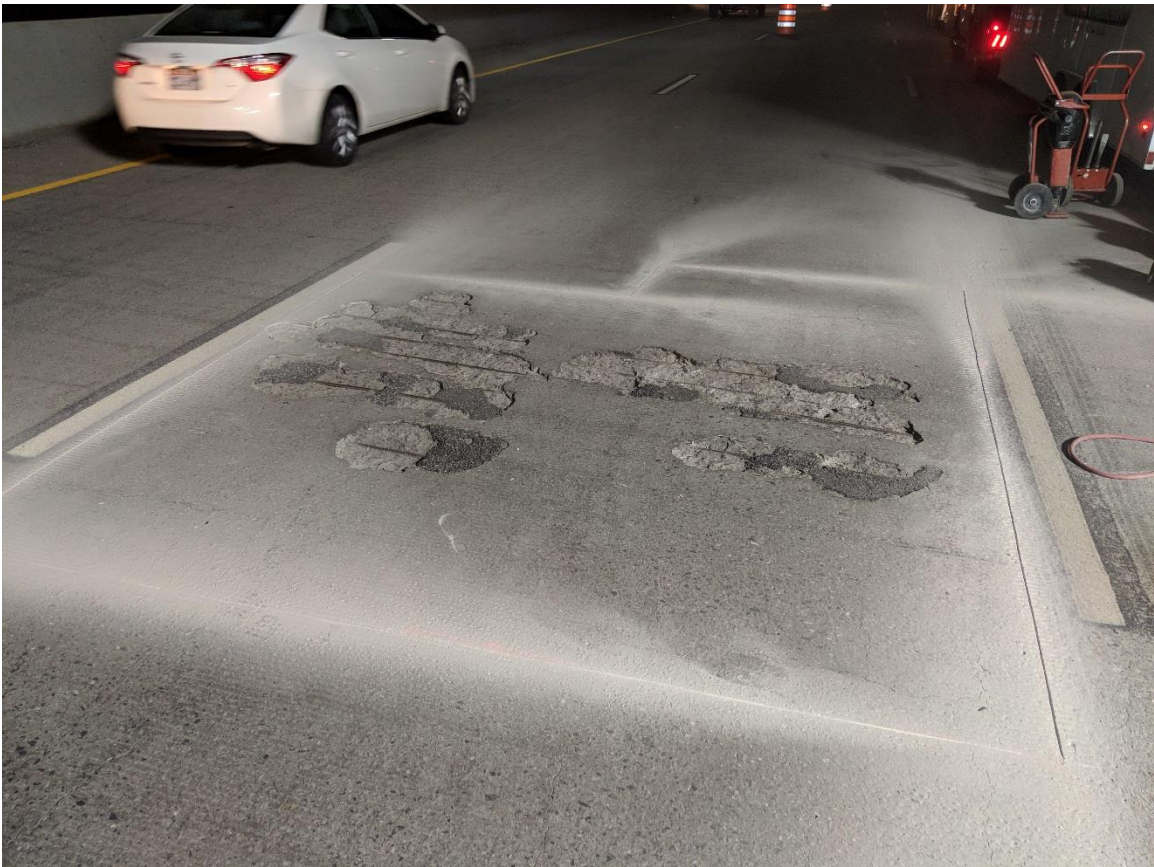
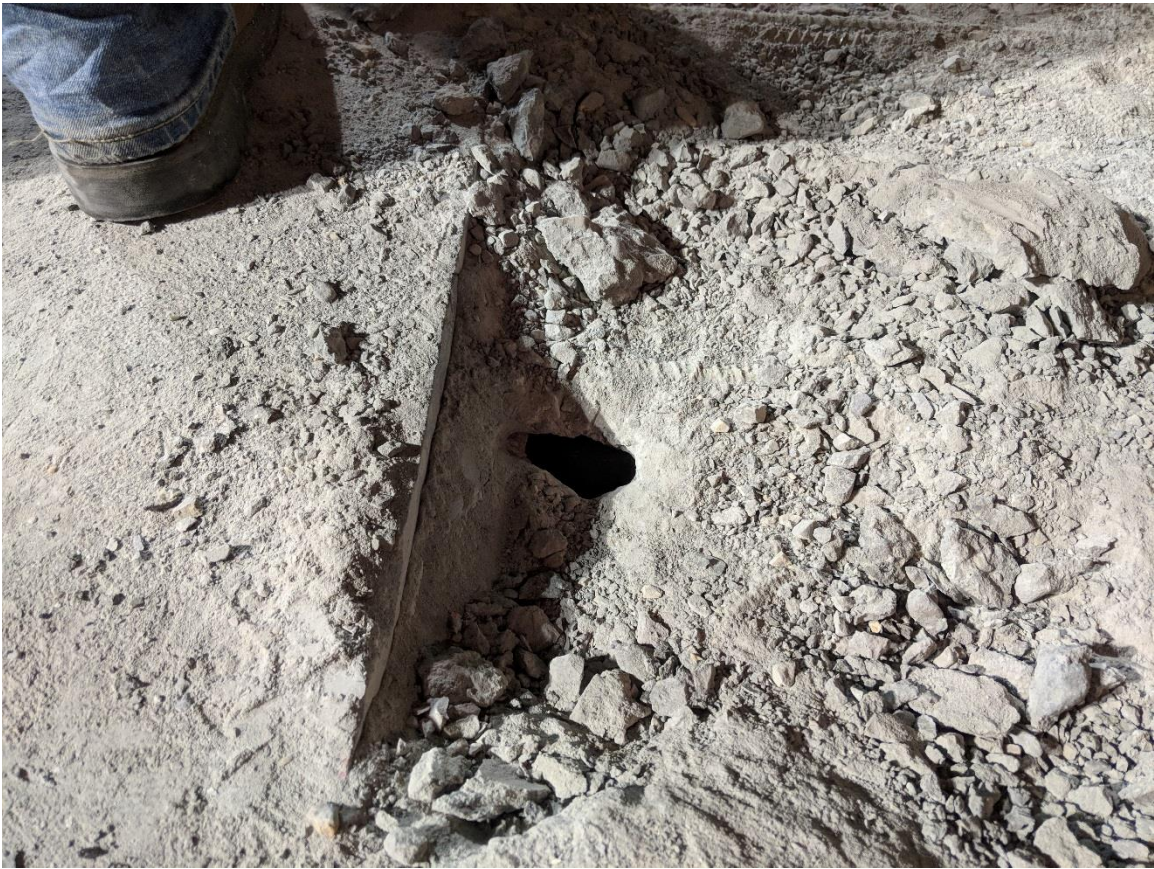
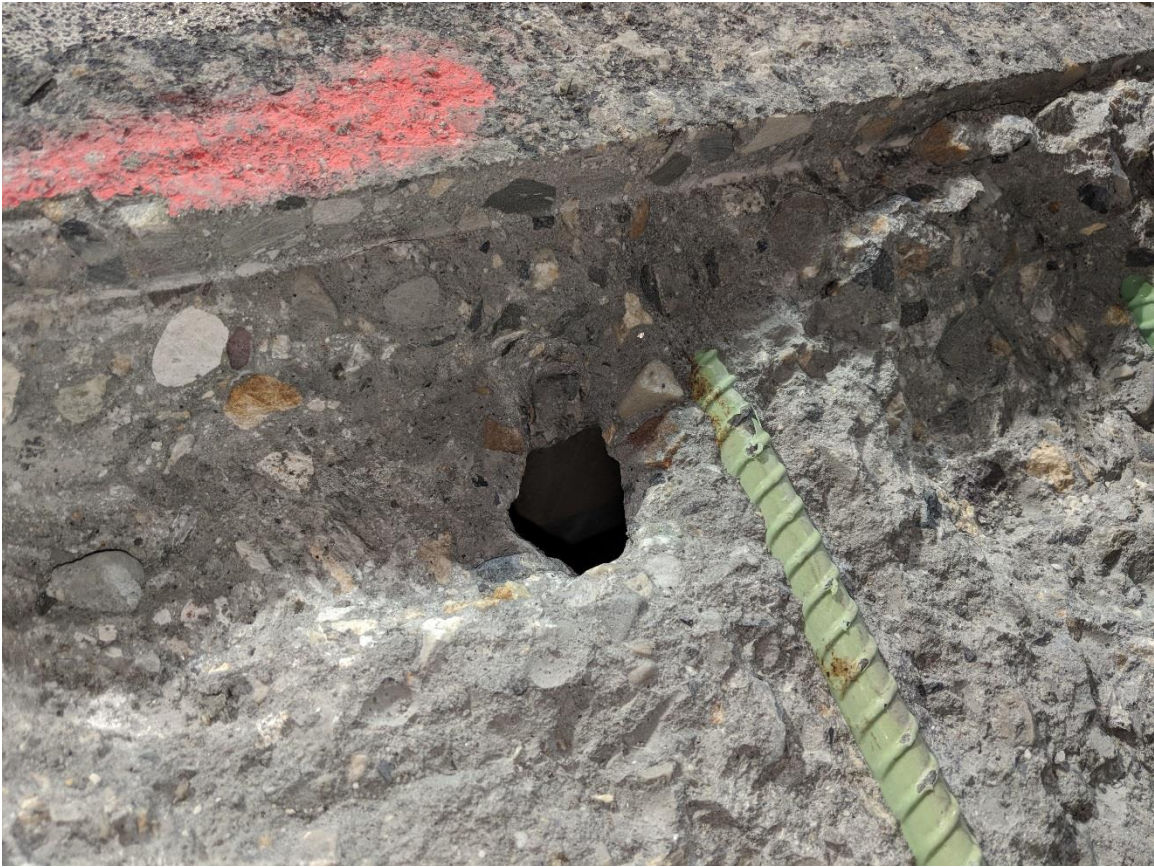
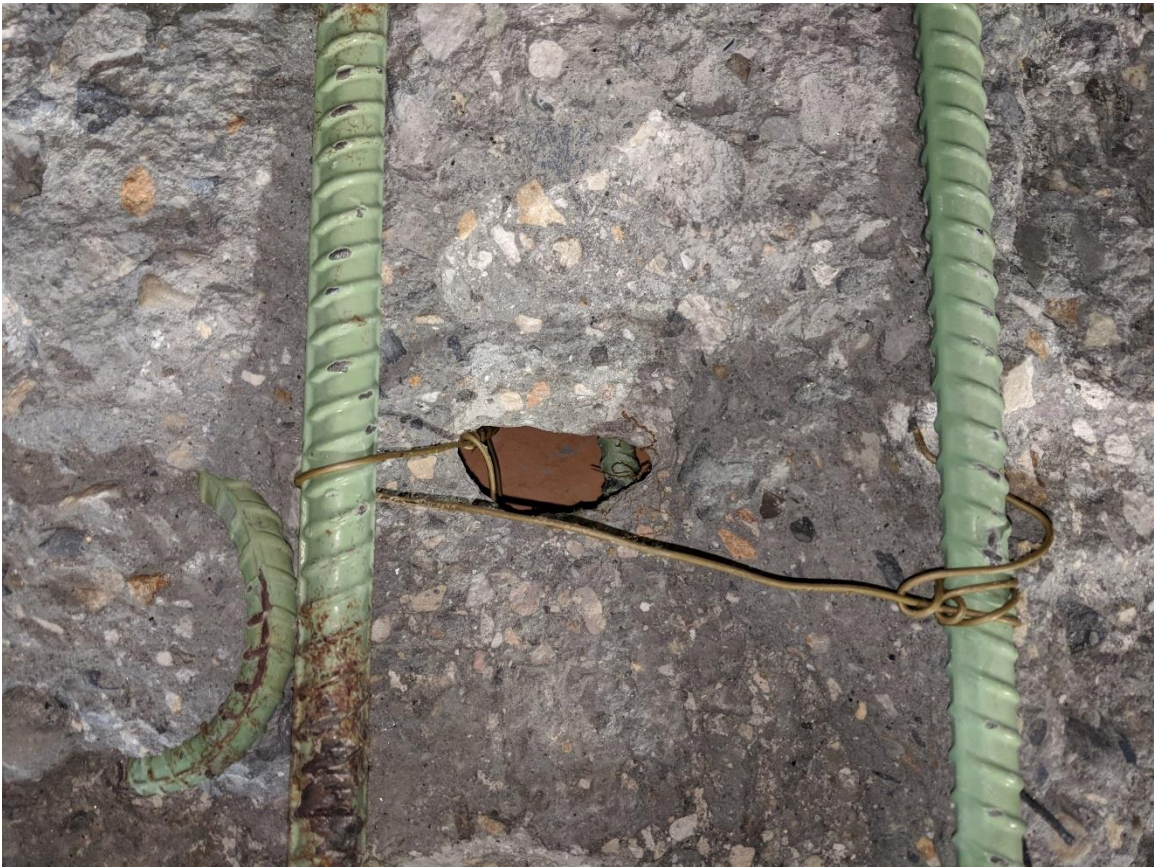
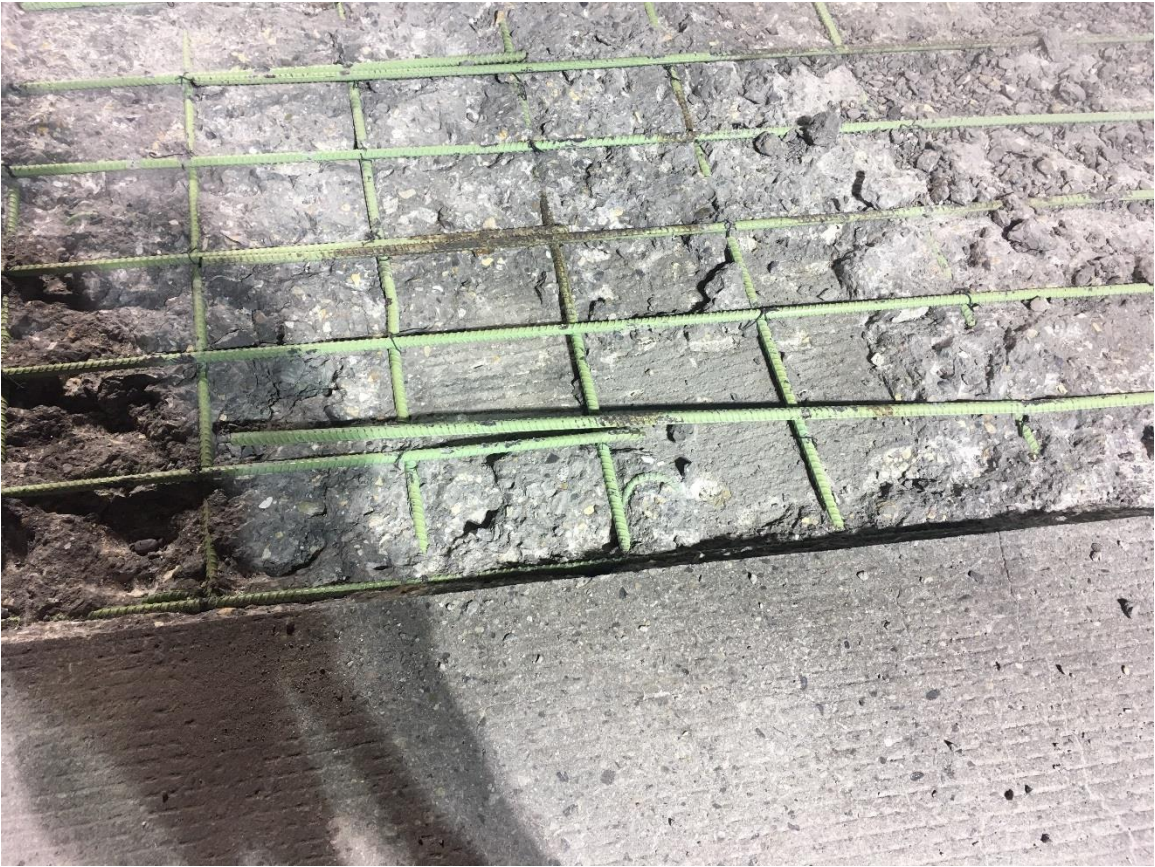
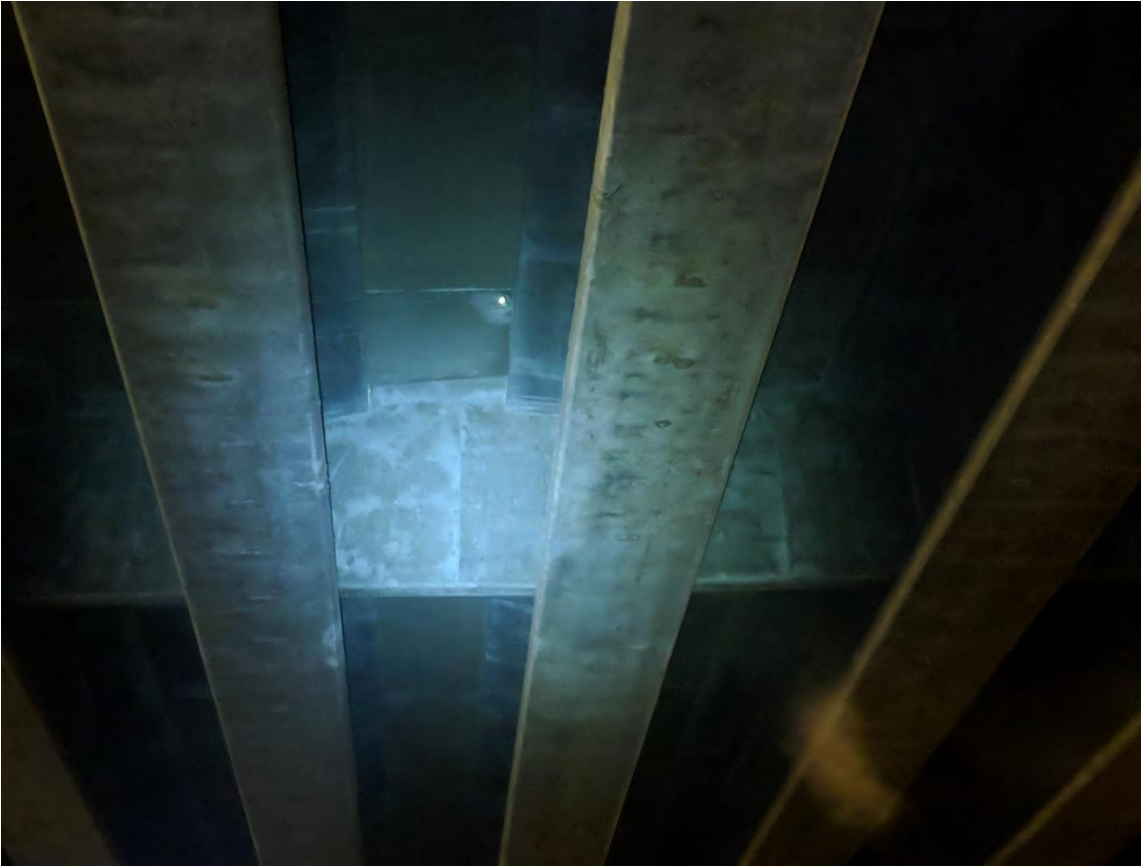
**Background:** Over the last 20 years Utah has incorporated half depth deck panels into bridge deck construction in order to reduce forming construction time, improve safety, and improve quality. Four inch thick precast panels are placed on the girders and act as the bottom form of the deck. A four inch cast in place concrete section is then placed over the top of the precast panels. Recently a patching project for one of these deck was completed. As the delaminated concrete was removed from the cast in place section of the deck a full depth hole formed through the panel at the joint between the panels. It was a small puncture on the top of the panel which extended to an approximately one foot by one foot spall on the underside of the panel. This bridge was recently inspected and no defects were found in the precast panels during this inspection. Leaking at the joints of the panels was not noted.
